NWC TP 5715

Benson Incident: Comparison of Burn Patterns of Boxcar Damaged in the Incident and an Experimentally Burned Boxcar

W. S. McEwan

Naval Weapons Center

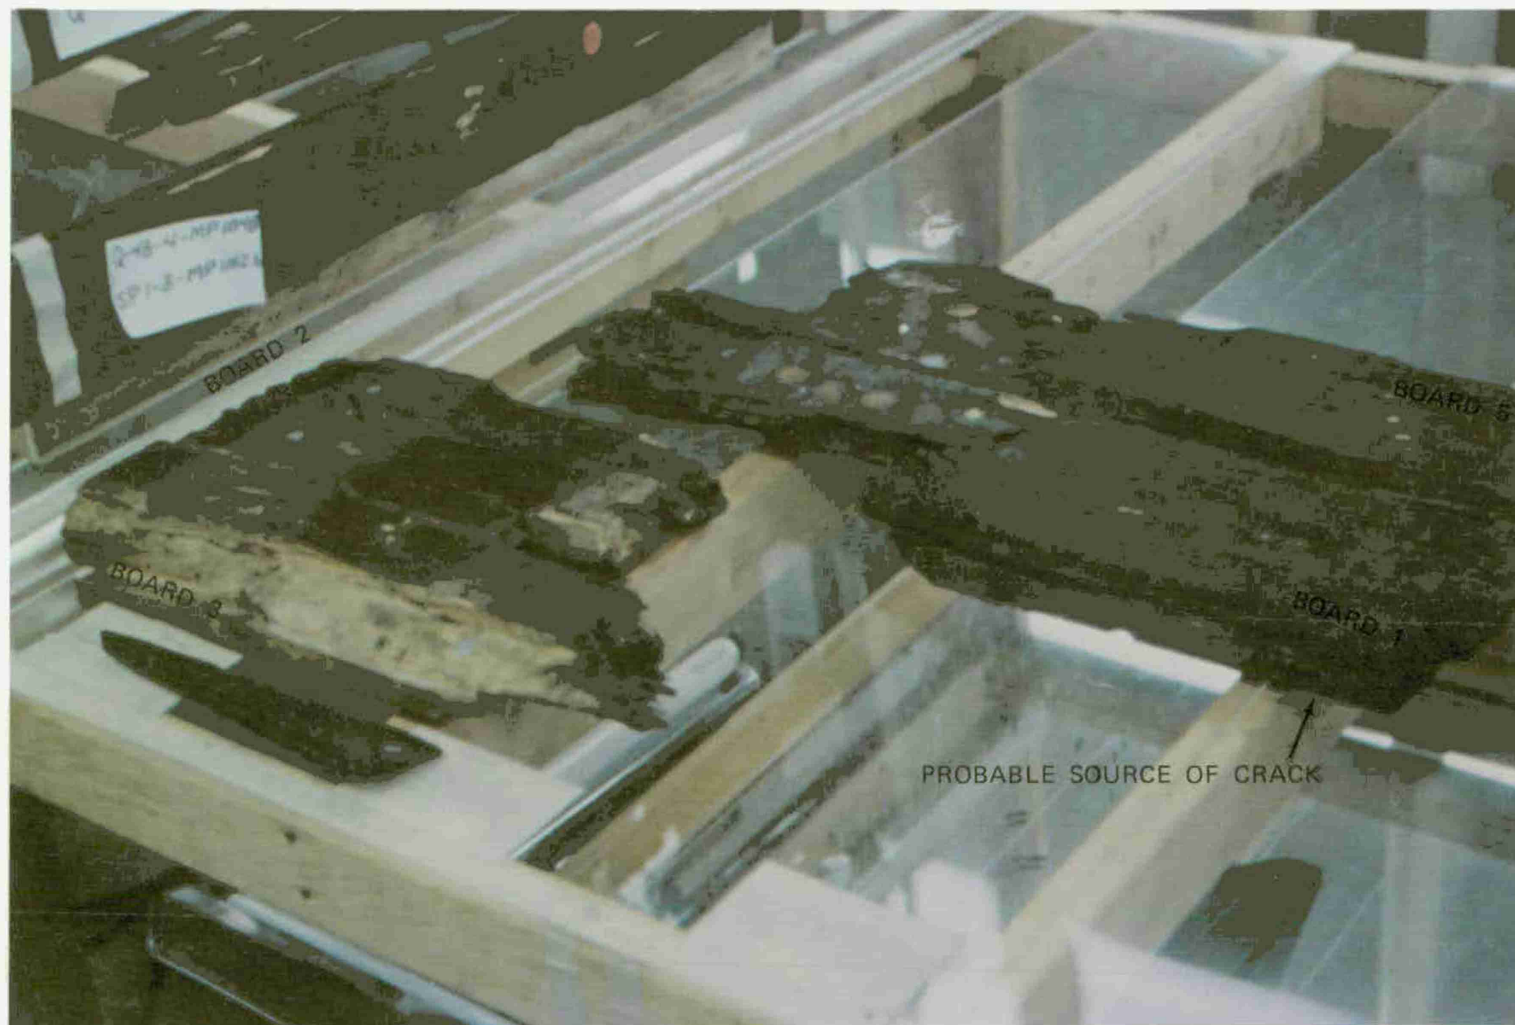
FIGURE 1. Burn Pattern of Top Surface of Floorboards of Reconstructed Boxcar.

Figures 1 and 1A compare the top surface of the floor of the boxcars. Note that the general wide area of burn is not very deep, except along the "penetration" crack marked (a) in Figure 1A and that along this crack the burn extends laterally to the outside end of the floor-board marked (b). This is also the case near the end of Board 2 and

Board 1 in Figure 1. The unburned bands running across the floorboards show in both Figures 1A and 1 that the floor was protected by the wooden pallet resting on the floor.

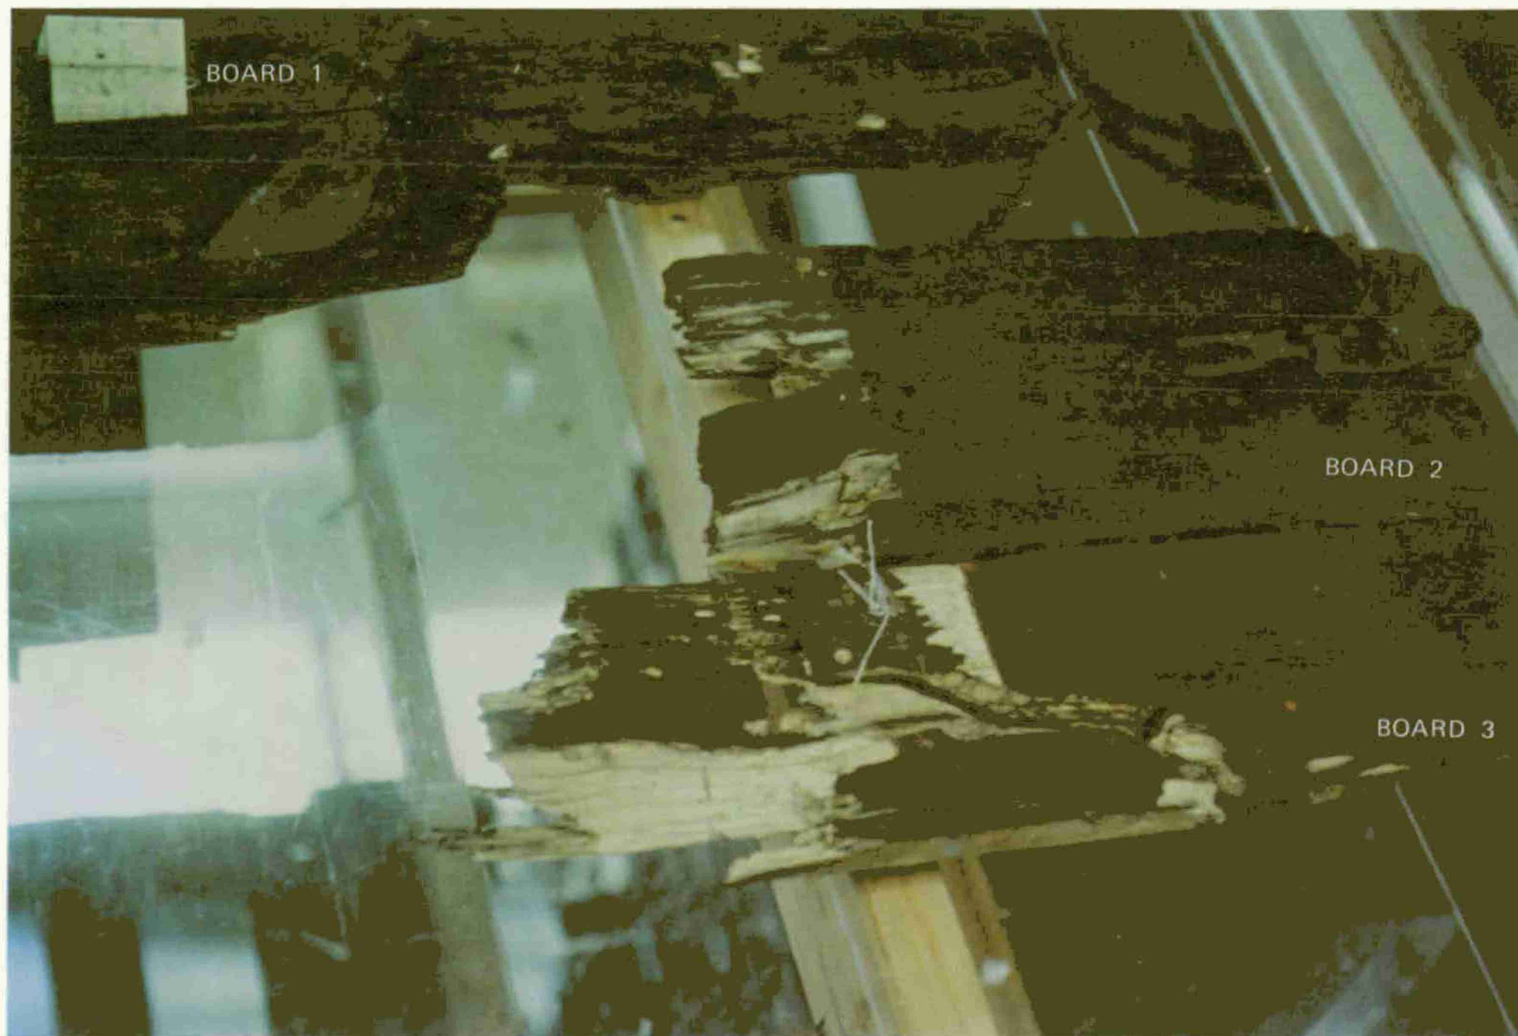
FIGURE 4. Burn Pattern of Bottom Side of Floorboards of Reconstructed Boxcar.

Figures 4 and 4A present another view of the same boards seen in Figures 3 and 3A. The underside area of the reconstructed boxcar (Figure 4) which would correspond to the heavily charred area along the left side of Figure 4A was apparently blown away in the form of very small pieces which were never recovered.

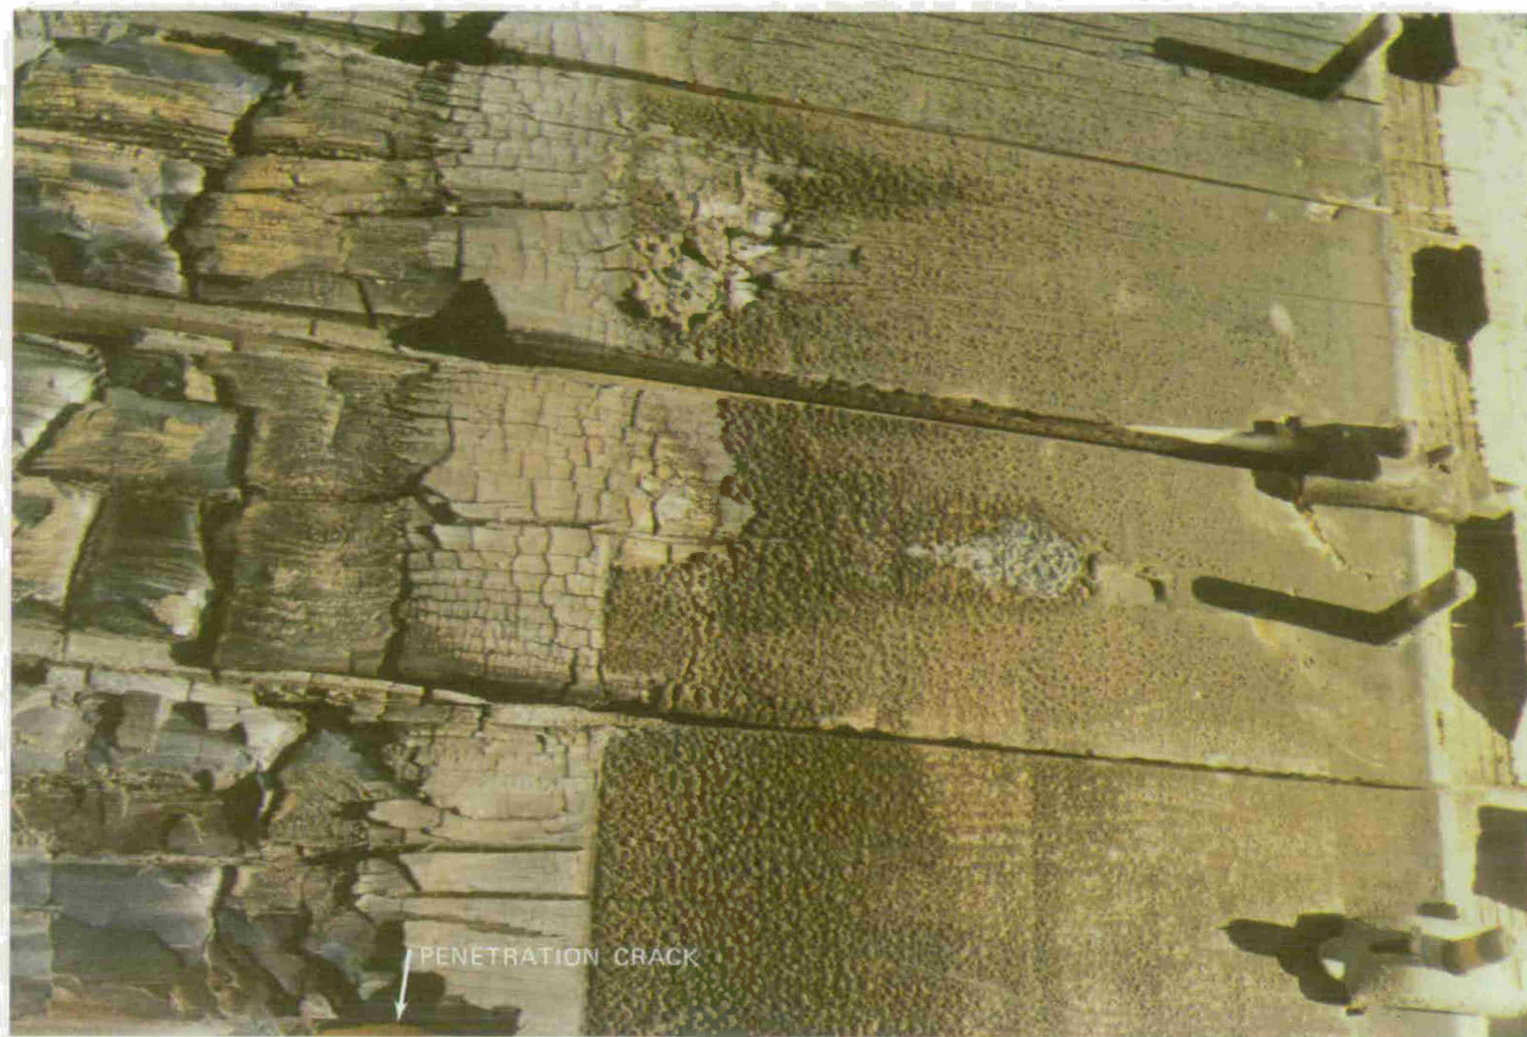
FIGURE 4A. Burn Pattern of Bottom Side of Floorboards of Experimental Boxcar. The penetration crack called out here is the same one shown fully in Figure 3A.

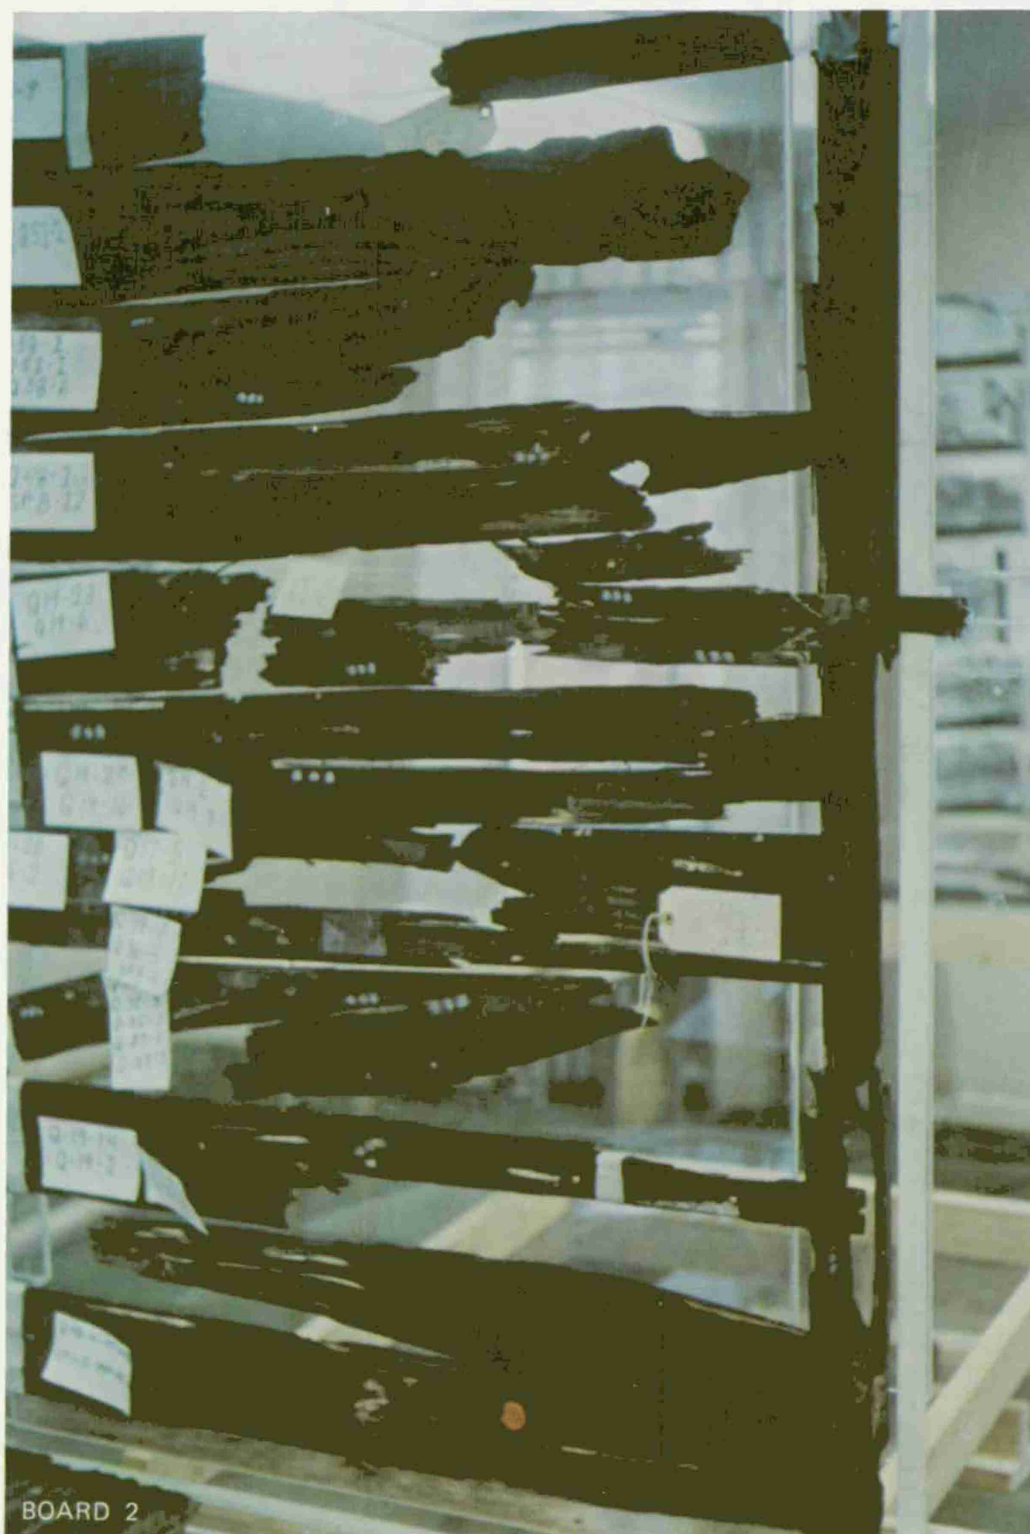
FIGURE 5. Burn Pattern of Inside Sidewall of Reconstructed Boxcar.

Figures 5 and 5A show the walls in the vicinity of the fire inside the car surfaces. Figure 5A shows the end of the experimental car, whereas Figure 5 shows the side of the reconstructed car. It should be noted that the charring seen in Figure 5A has been caused by the secondary burning and directing of the flames by the wooden pallets since the floor area inside (see Figure 1A) is not much affected and the side wall shown in Figure 5 is even less affected.
